BOEING AEROSPACE CO HOUSTON TX SPACE DIV
SNEAK CIRCUIT ANALYSIS OF F-4C FLIGHT CONTROL SYSTEM, (U)
SEP 74 P F STOKES

D2-118545-1

Sneak Circuit Analysis of F-4C Flight Control System

SEPTEMBER, 1974
HOUSTON, TEXAS

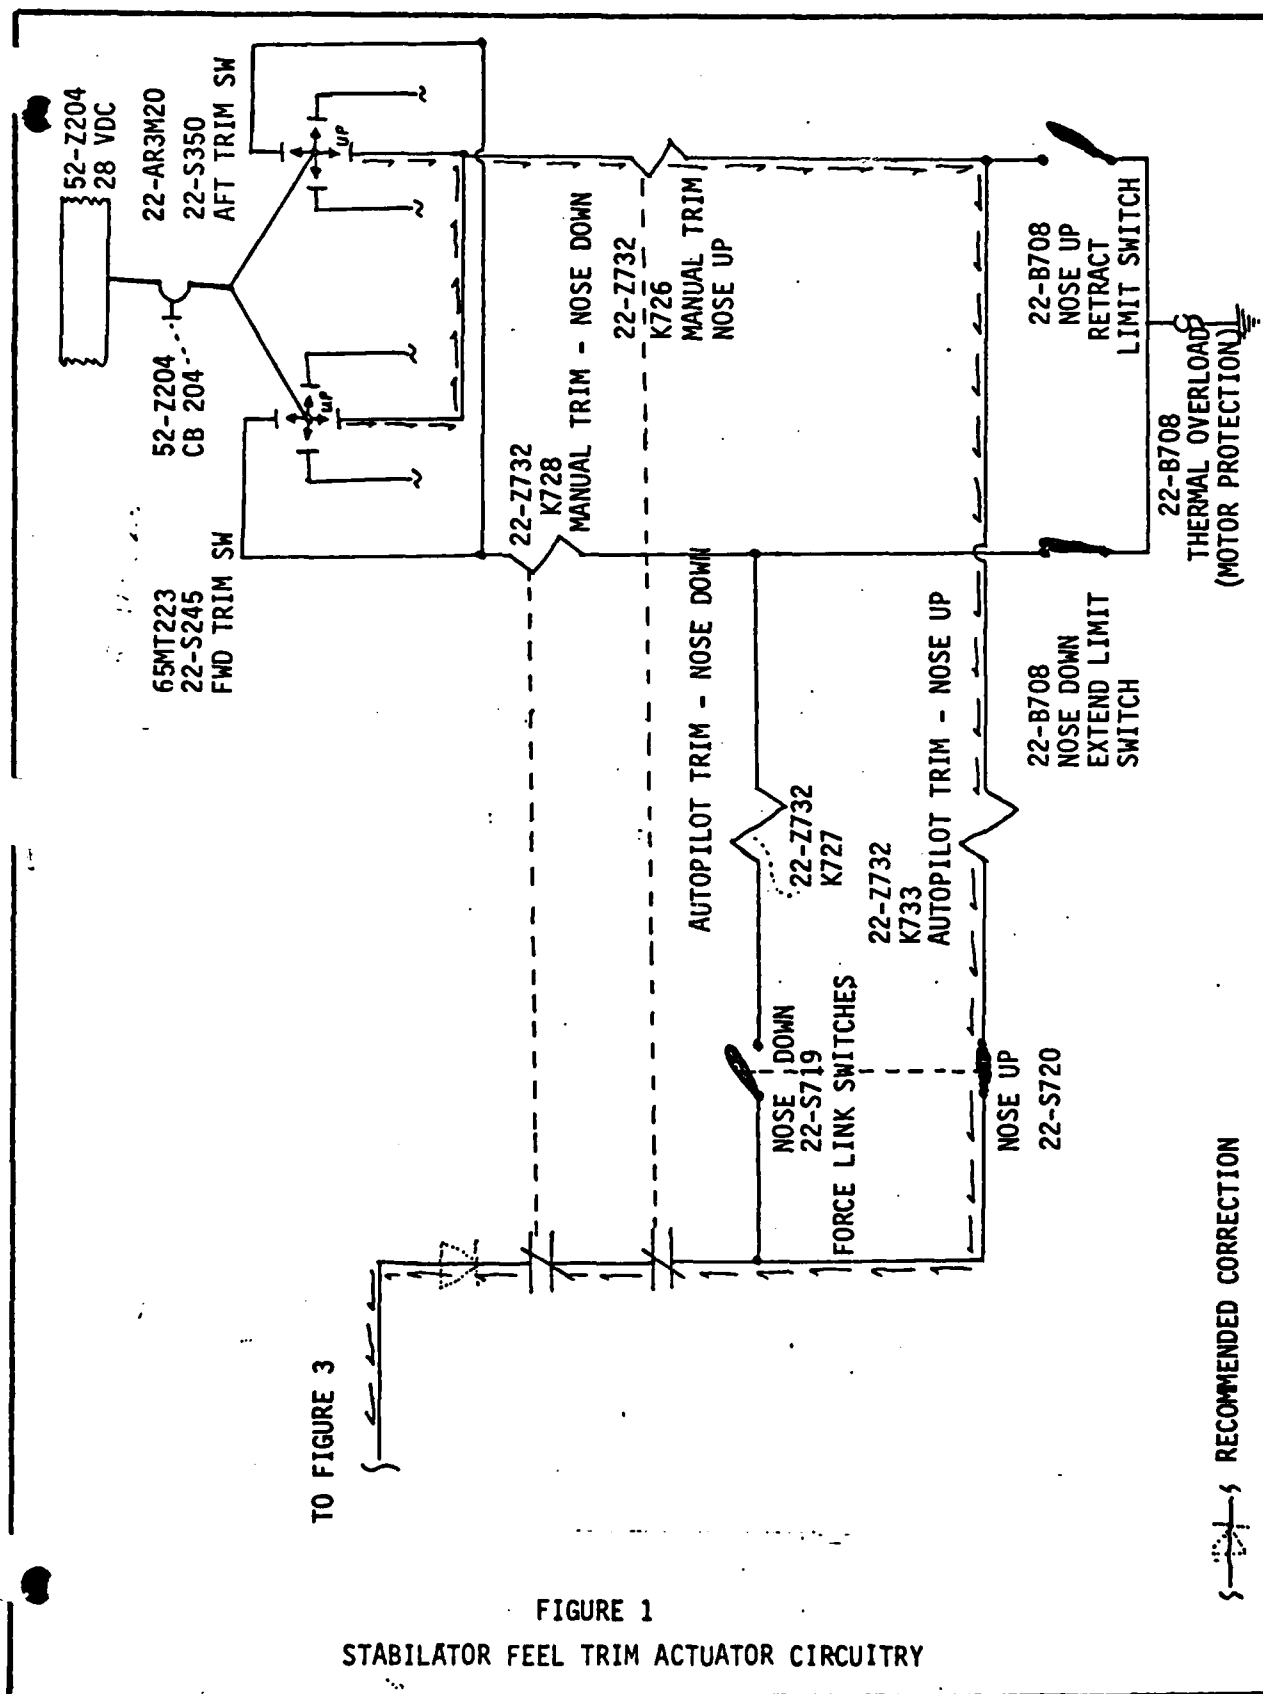
FIGURE 2

- Path C. As shown in figure 4, power can flow to the Parallel Pitch Shutoff Valve in ref. des. 65-U716 and to the Pitch Engage Relays (K3G and K3C) in ref. des. 65-AR305. This could cause the Pitch Channel of AFCS to be enabled even though AFCS is disengaged.

The Altitude Hold Circuitry and Roll and Pitch Channels of the Autopilot may be powered while AFCS is disengaged. There may be damage to AFCS relays due to relay chatter.

Add a diode in the location shown in Figures 1 and 2.

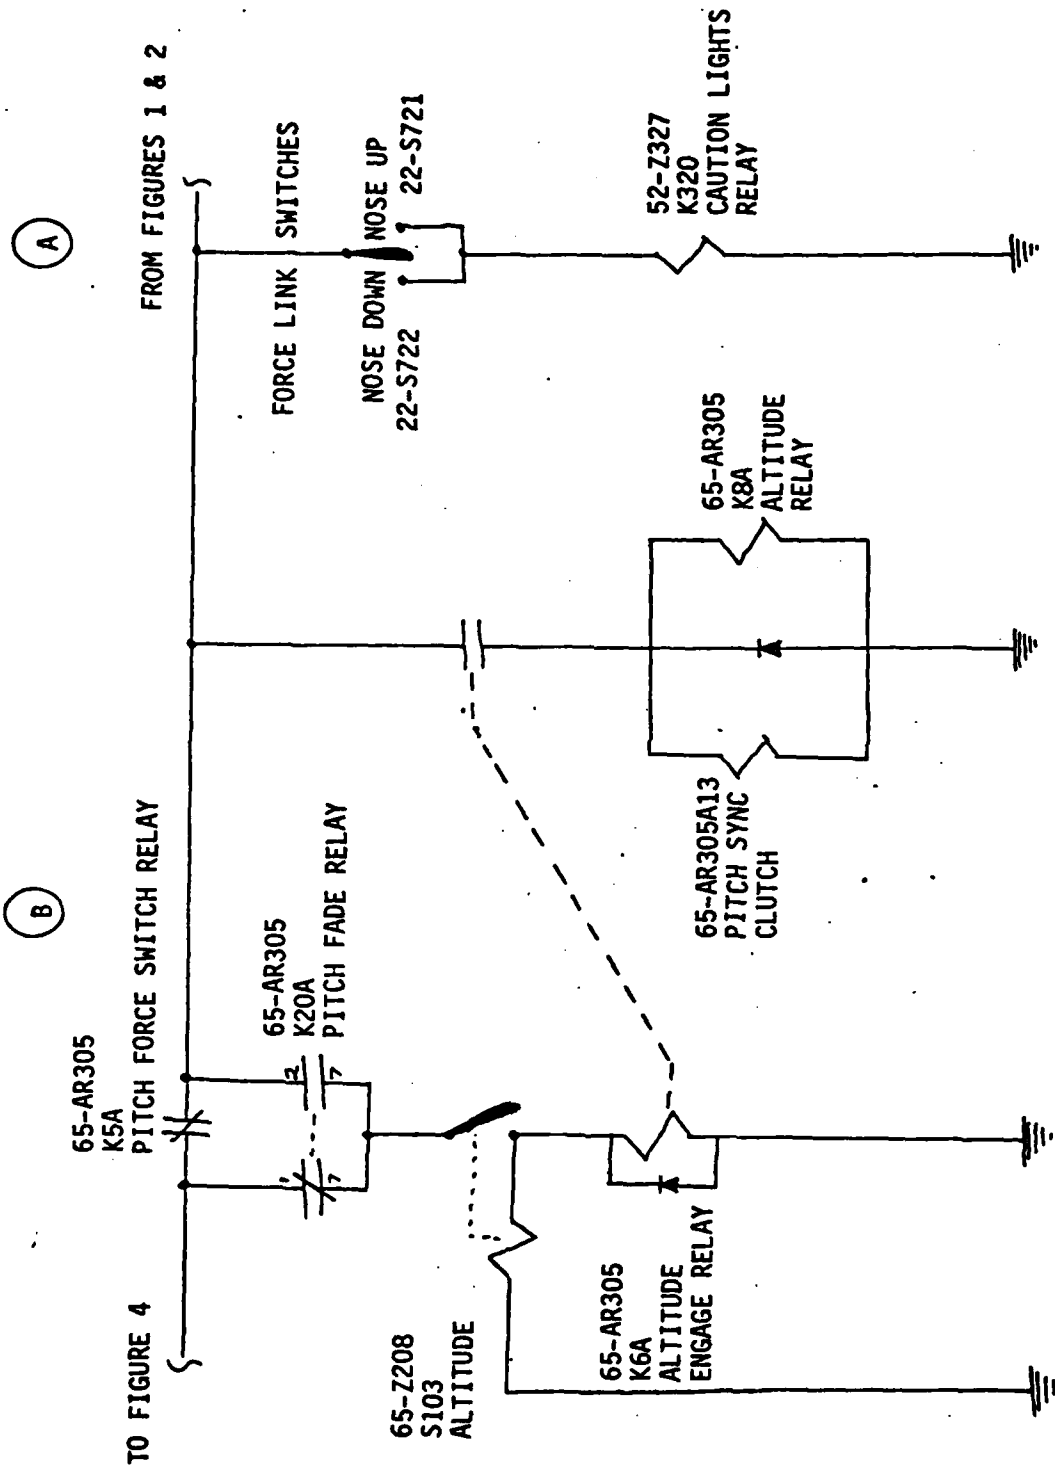
FIGURE 3

- Path E. As shown in figure 5, if the FWD or AFT Pitch Force Switch (S202) in ref. des. 65-MT223 is thrown, the Pitch Force Relay (K5A) may be energized. If it energizes, it would cause relay chatter since its contacts in figure 3 are between it and the power source.

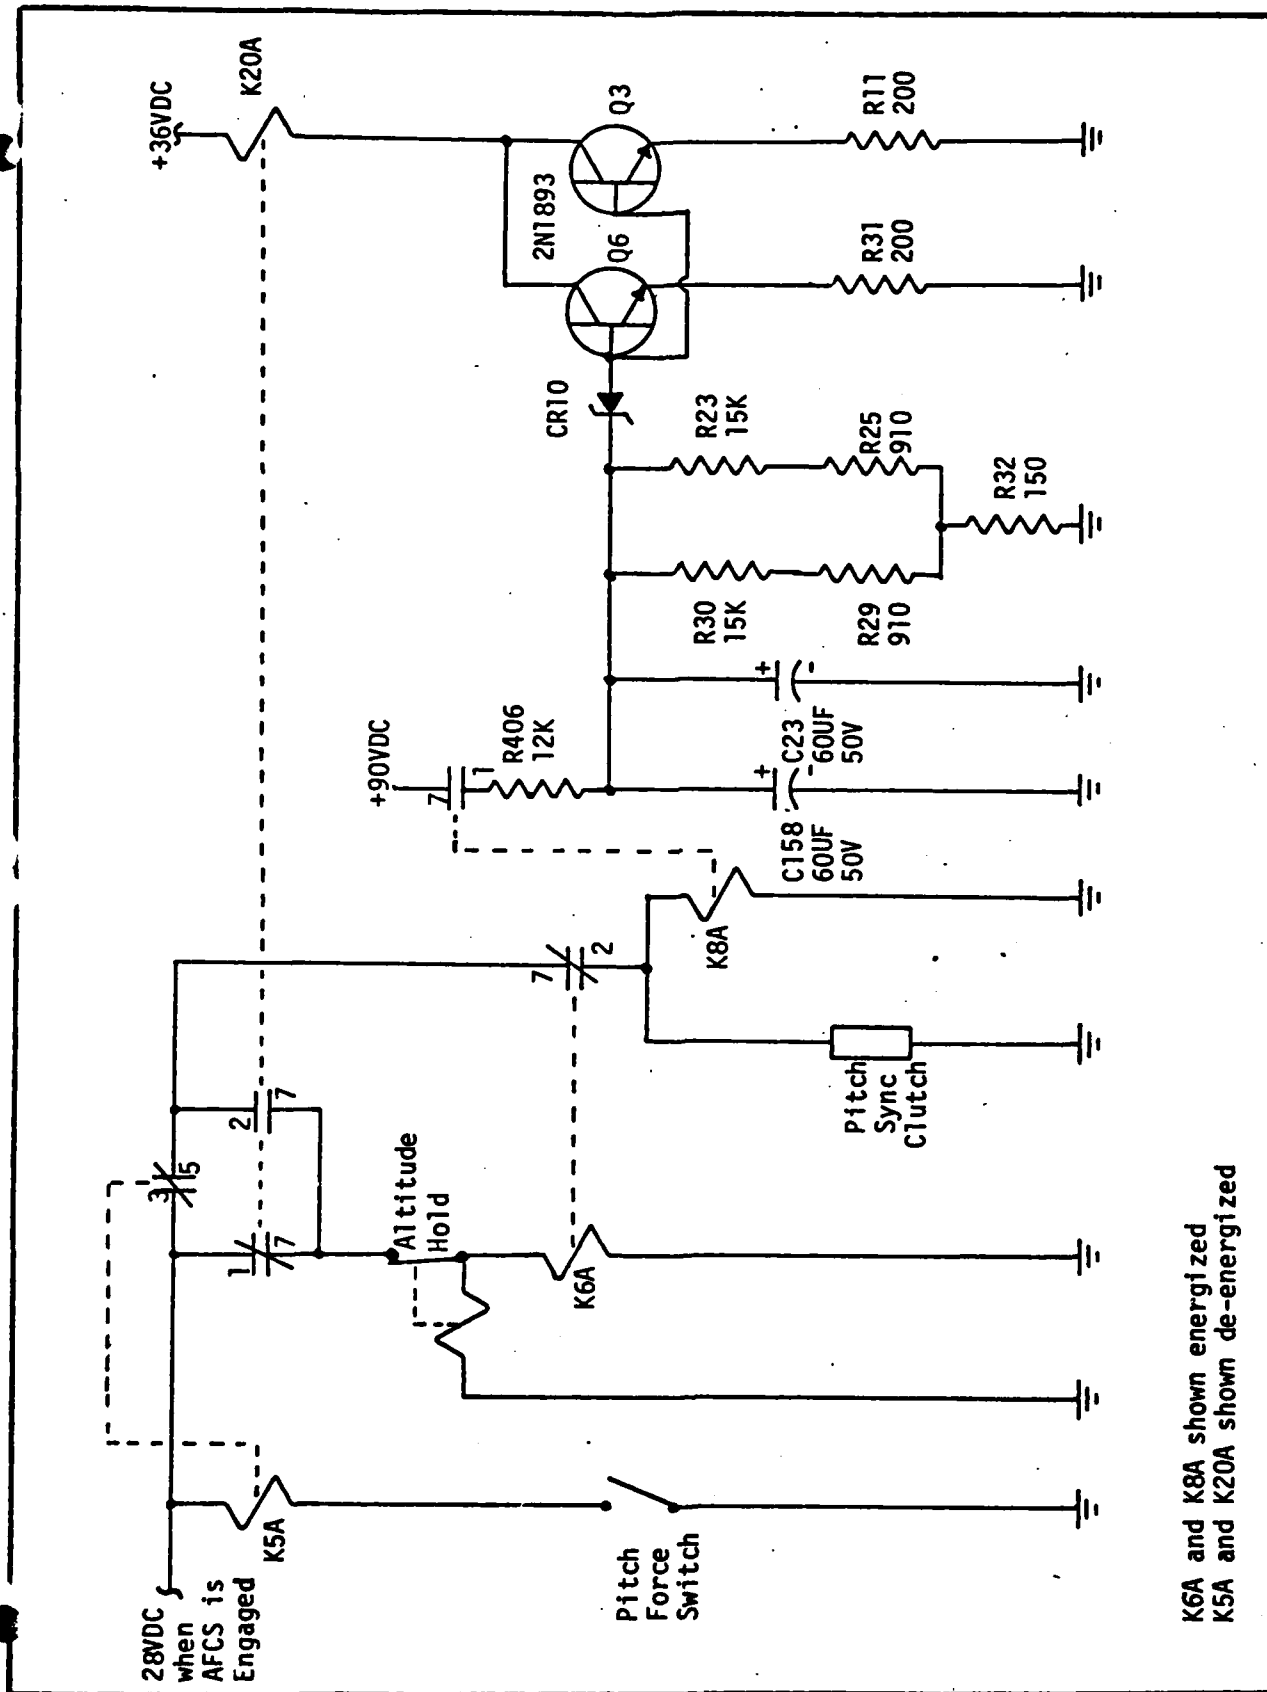
If Pitch Force Switch is opened before Altitude Hold drops out, the Air Data Computer error signal will cause the aircraft to return to the reference altitude.

K6A and K8A shown energized
K5A and K20A shown de-energized

The connections of K20A normally closed contact pins 1 and 7 and normally open contact pins 2 and 7 should be reversed.

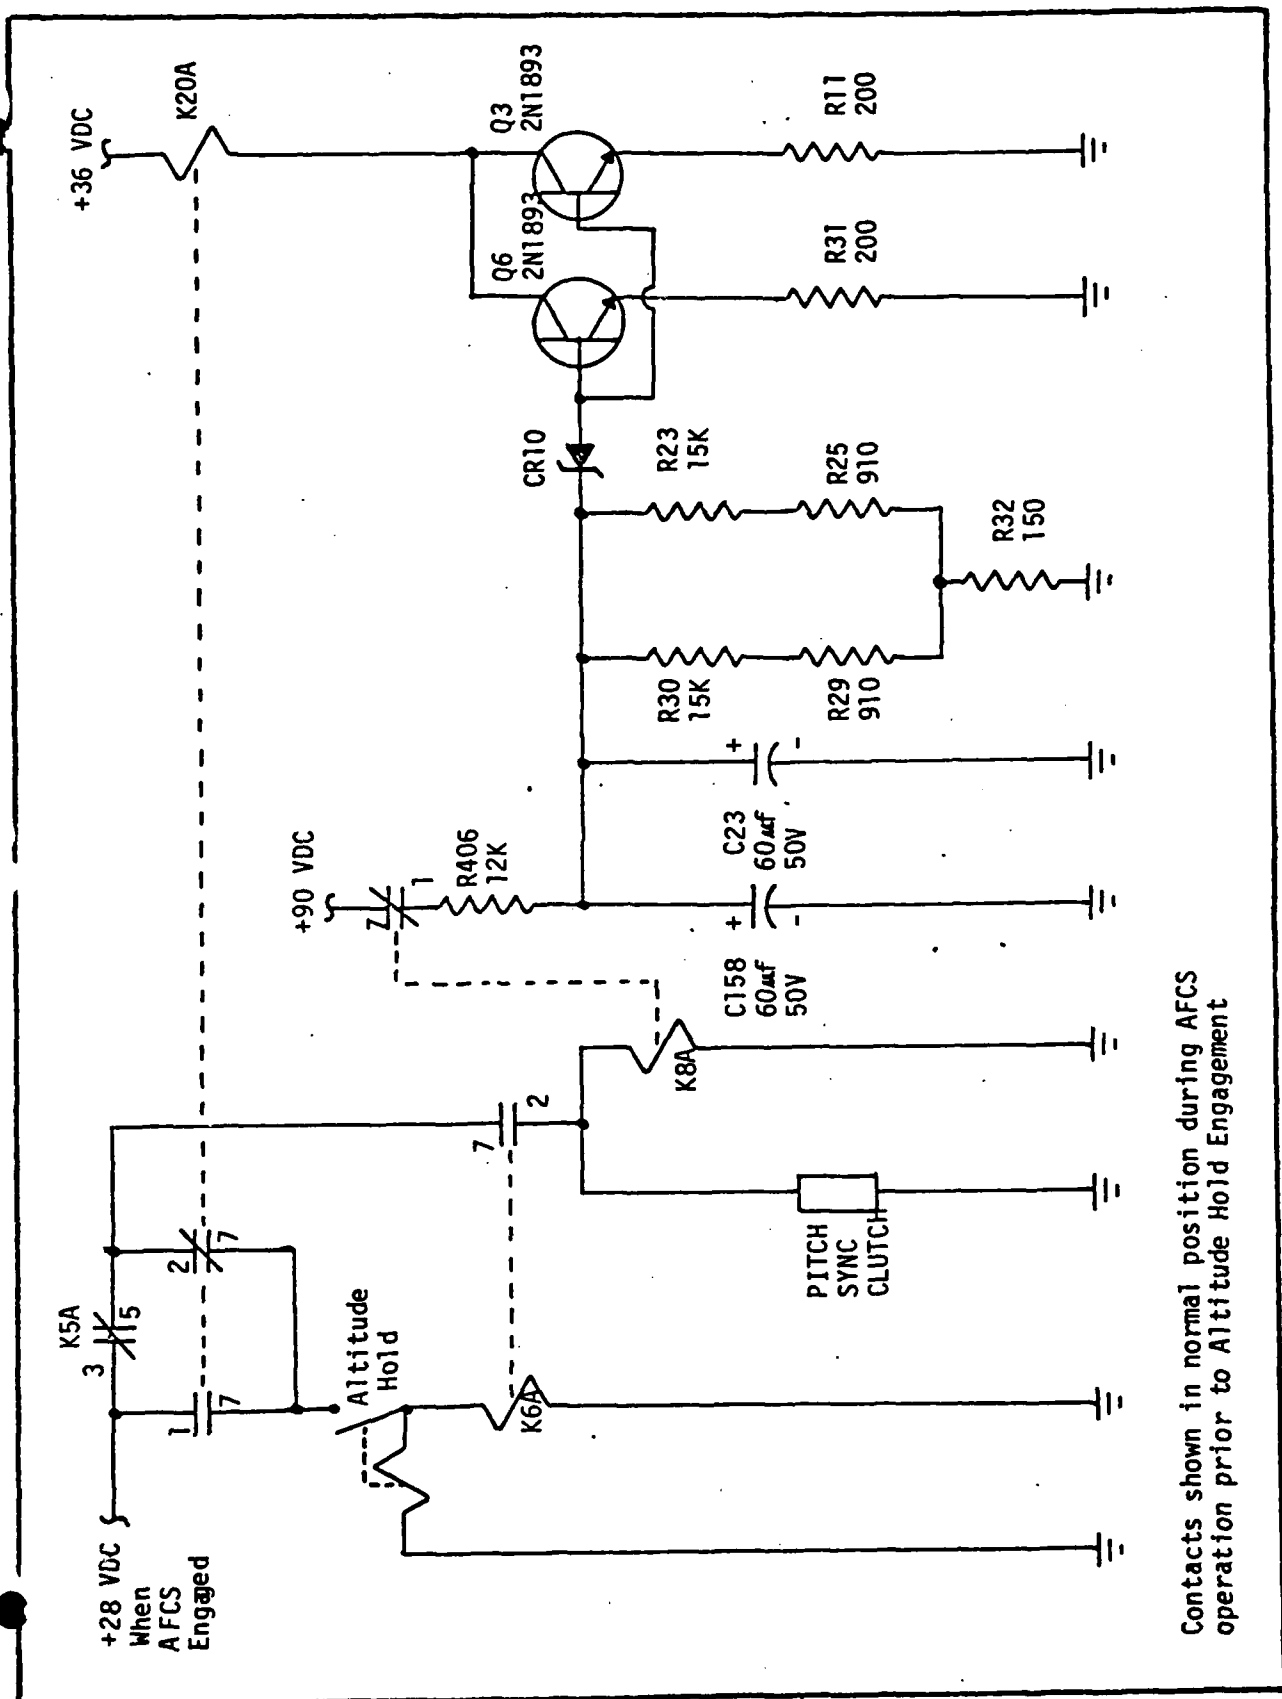
Contacts shown in normal position during AFCS operation prior to Altitude Hold Engagement

Replace relay K20A with a relay with make before break contacts.

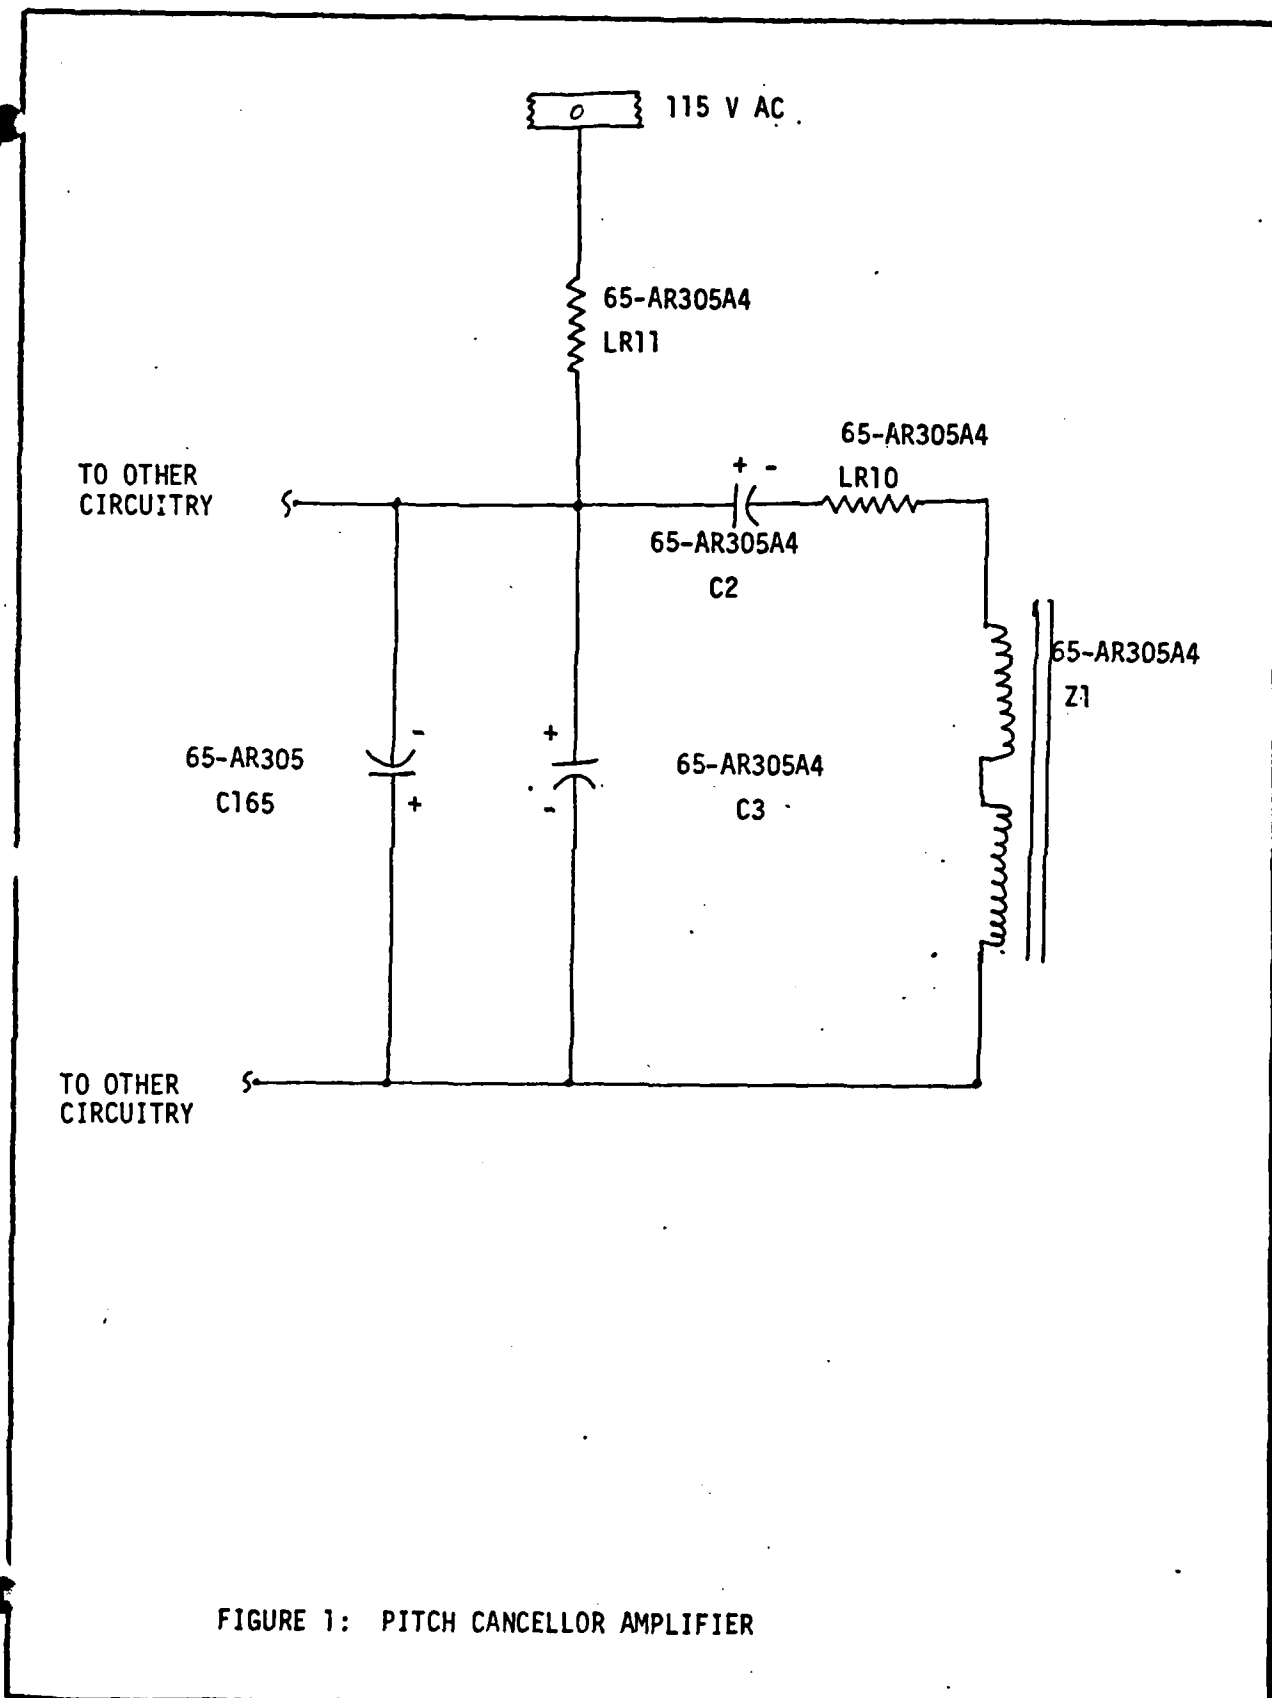
FIGURE 1: PITCH CANCELLOR AMPLIFIER

Capacitor C165 in ref. des. 65-AR305 is wired in parallel with capacitor C3 in ref. des. 65-AR305A4. The drawings in references 2 and 3 above show these capacitors wired with opposite polarity as shown in Figure 1. If these are electrolytic capacitors, one of them may burn out.

Either capacitor C165 or C3 may burn out.

Reverse polarity of capacitor C165.

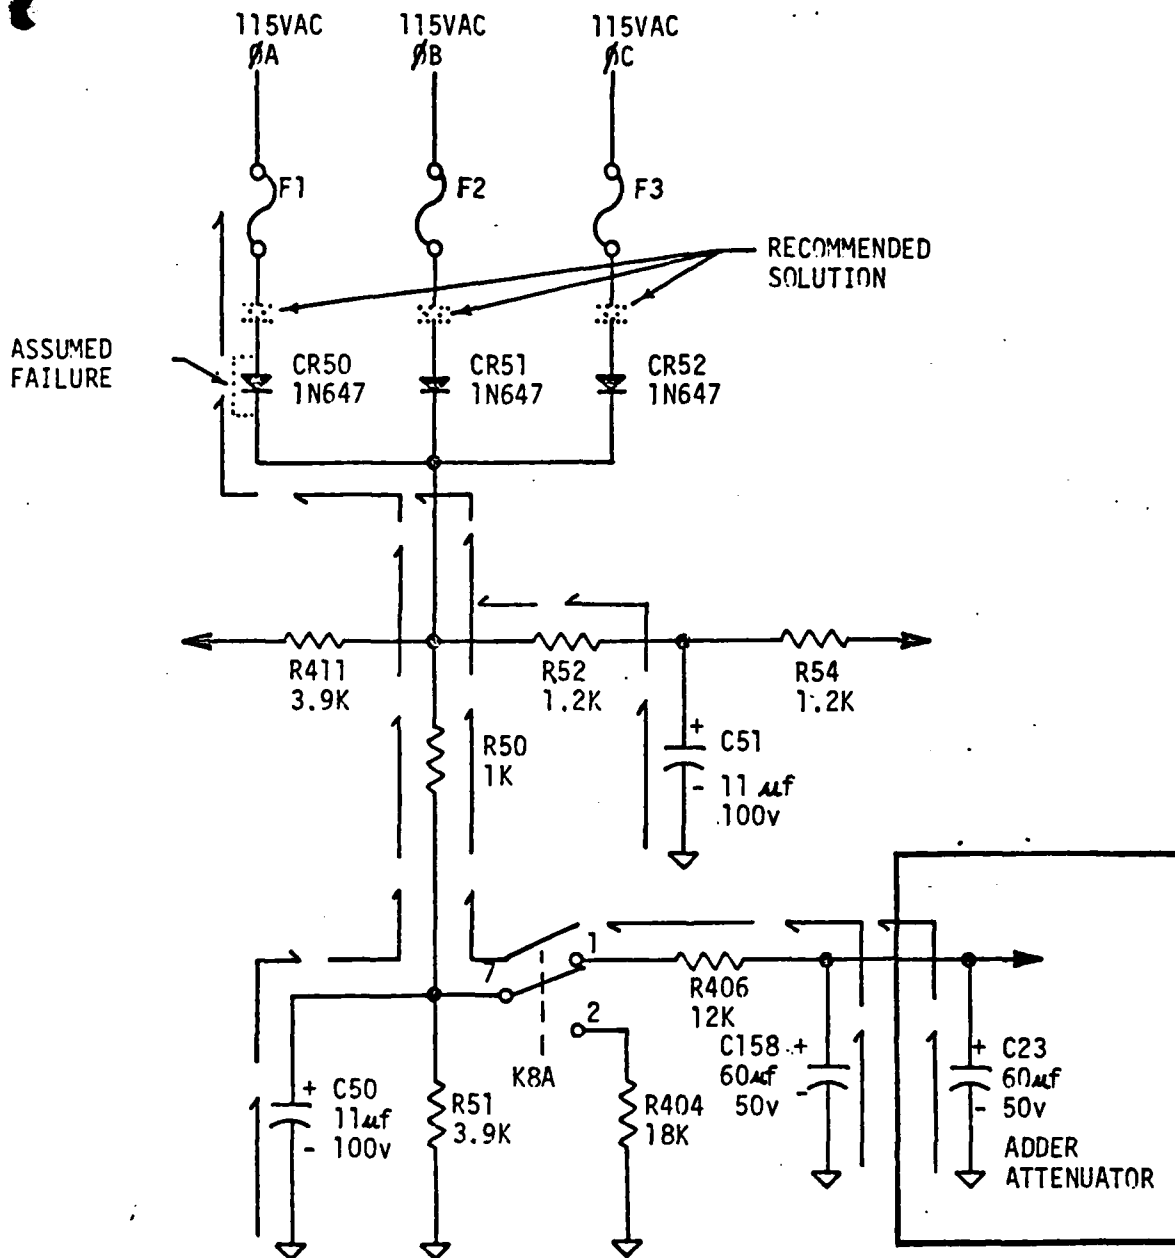
DESIGN CONCERN REPORT F-4C-7

Diodes CR50, CR51 and CR52 rectify the incoming 115VAC, 400 Hz, 3 phase power to provide 135 VDC to the Adder Attenuator and Electronic Switch Monitor. This voltage is filtered by capacitors C50, C51, C158 and C23. C23 is located in the Adder Attenuator Module. The remaining capacitors are chassis mounted components. Should any of the diodes fail in the shorted mode (then fail open) each of the four capacitors will be subjected to reverse current during the negative portion of the cycle for the phase containing the shorted diode. Per reference 4 these capacitors are of the Tantalum Sintered-Slug type. Per MIL-STD-198C, Section 802, paragraph 2.1.2 these capacitors cannot withstand any reverse voltage.

Capacitors may fail immediately or be damaged to the extent that they will fail later - possibly in flight. Capacitor C51 failure will prevent AFCS from being engaged. Capacitor C158 or C23 failure results in the loss of the pitch fader effect. Capacitor C50 failure results in the loss of both pitch and roll fader effects.

← REVERSE CURRENT PATH

Add one additional diode in series with CR50, CR51 and CR52 as shown in the attached figure.

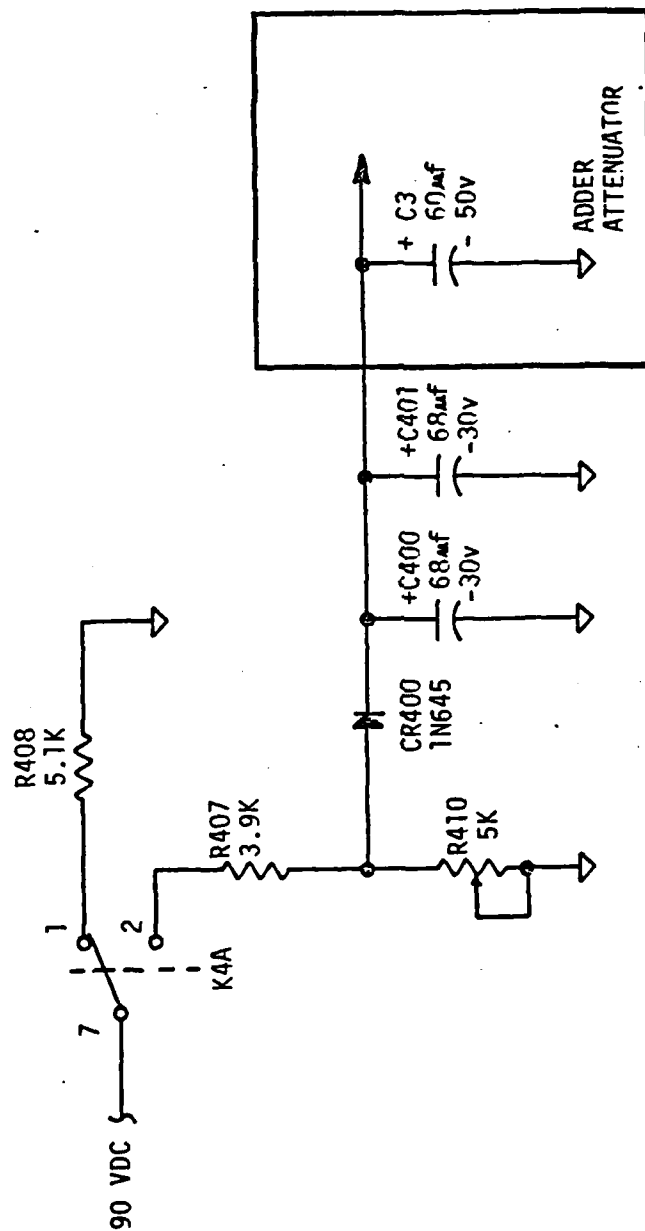
DESIGN CONCERN REPORT F-4C-8

Capacitors C400, C401 in the chassis wiring and capacitor C3 in the Adder Attenuator are connected in parallel as shown in the attached figure. The working voltage for C400 and C401 is 30 volts and for C3 is 50 volts. Per reference 2, the nominal voltage across these capacitors is 31.9 volts. Depending upon the setting of R410 this can be as high as 39.8 volts. In either case, the working voltage for C400 and C401 is exceeded. This is in violation of MIL-STD-198C, Section 802, Paragraph 2.7.2.

Capacitor failure which in turn results in the loss of the roll fader effect in the Adder Attenuator module.

Replace C400 and C401 with capacitors with sufficient working voltage to withstand the applied voltages.

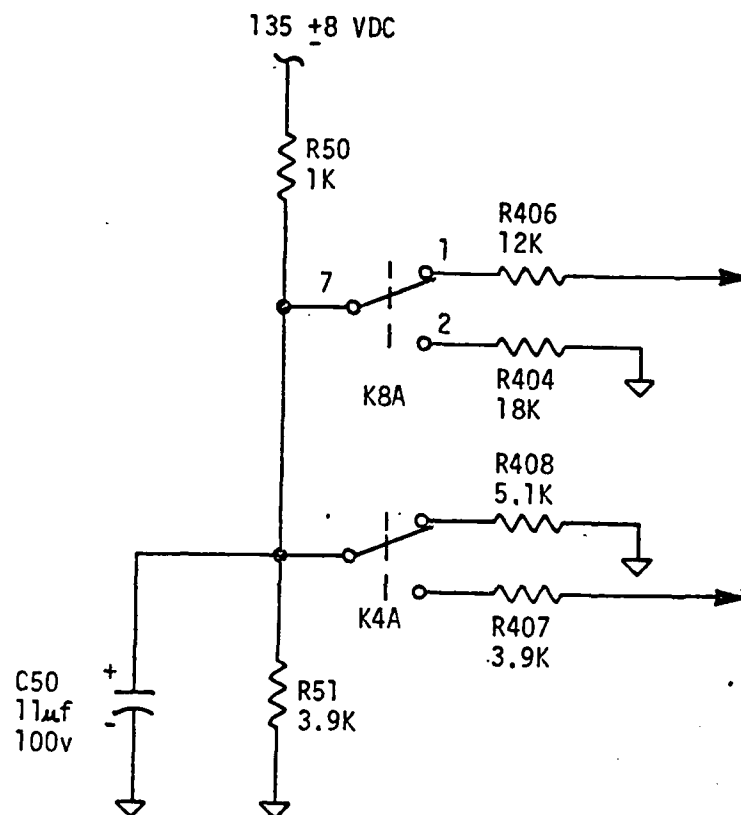
DESIGN CONCERN REPORT F-4C-9

Capacitor C50 filters the 90 VDC used to control the Pitch and Roll faders in the Adder Attenuator module. During the switching time of relay K4A the voltage applied to C50 is 109 VDC due to the loss of the 5.1K Ω load impedance. This exceeds the rated working voltage of the capacitor in violation of MIL-STD-198C, paragraph 6.5(d).

Capacitor failure which in turn results in the loss of the pitch and roll fader effects in the Adder Attenuator.

Replace capacitor C50 with a capacitor with sufficient working voltage to withstand the applied voltage.

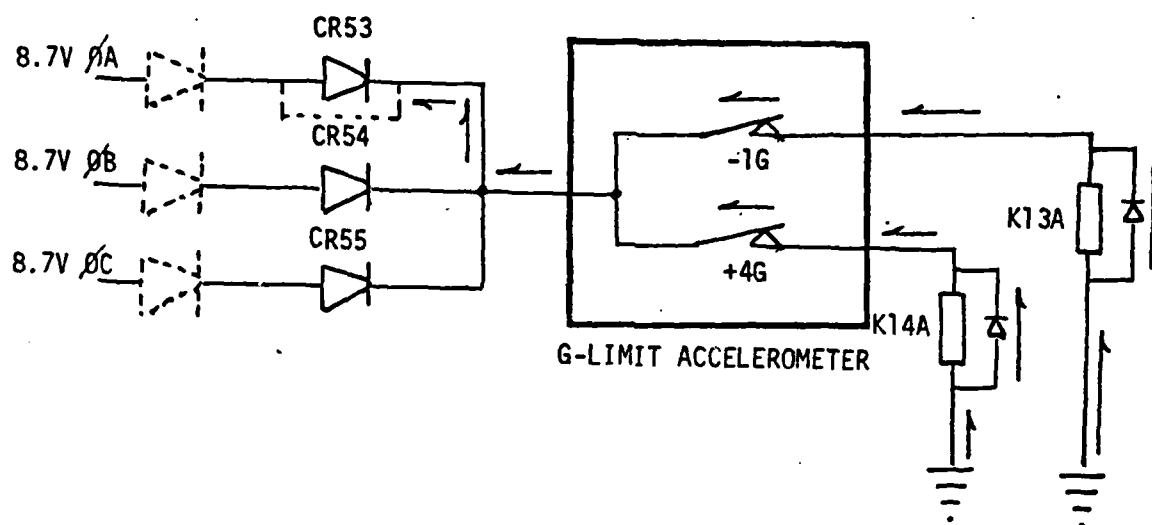
FIGURE 1 G-LIMIT ACCELEROMETER AND RELAYS

Diodes CR53, CR54, and CR55 rectify the incoming 8.7 VAC 400 Hz, 3-Phase voltage to provide 9.5 VDC to the G-limit relays through the G-limit accelerometer switches as shown in the attached Figure 1. If any of the three diodes fail in the shorted mode, the voltage to the G-limit accelerometer will be driven negative during the negative cycle of the phase containing the shorted diode. This will cause current flow through the suppression diodes of K13A and K14A in the forward direction, as shown, causing them to fail open. Also, during the negative portion of the shorted phase, the two remaining diodes will supply excessive current, causing one or both to fail open. The negative voltage at the input to the G-limit accelerometer will have the same effect as opening the G-limit switches: De-energizing of K13A and K14A and disengaging AFCS (AFCS engage logic is shown in Attached Figure 2).

AFCS will not remain engaged after failure of any of the diodes in shorted mode.

Add an additional diode in series with each of the three diodes as shown in Figure 1.

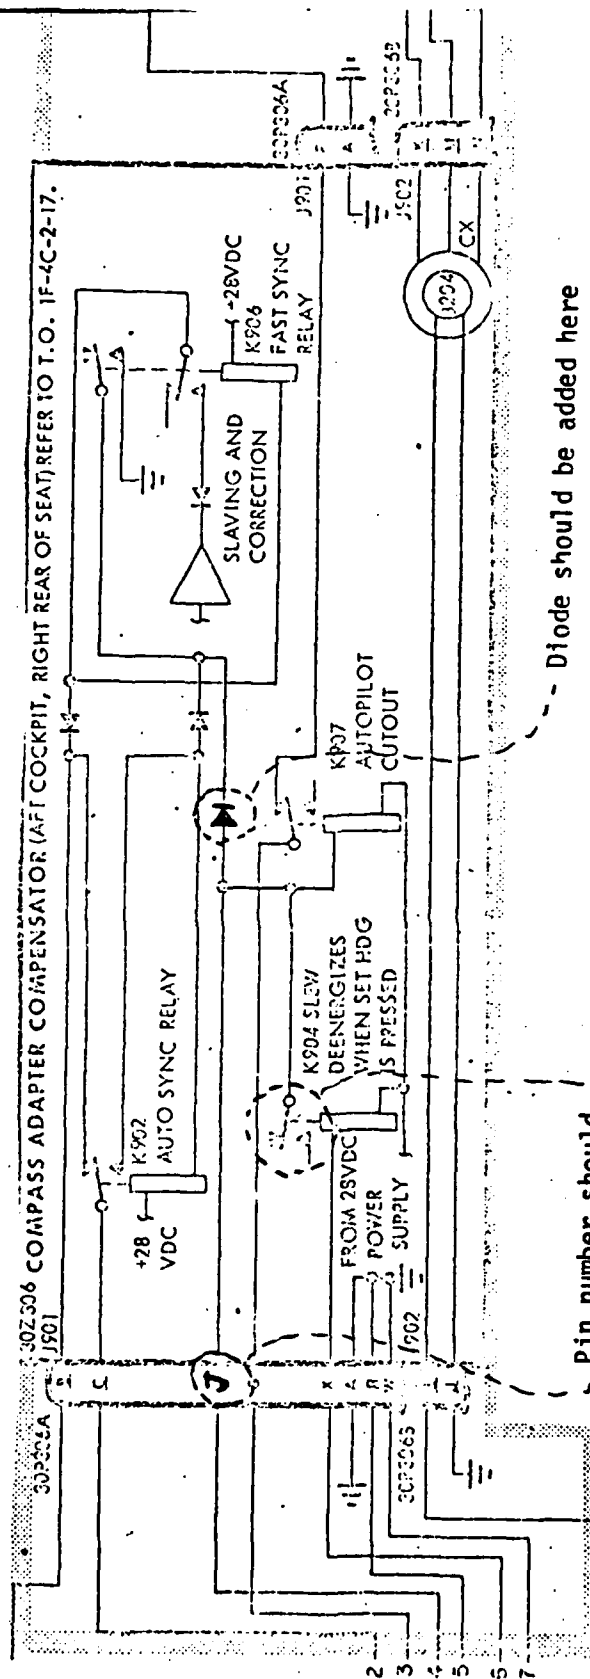
T.O. IF-4C-2-16, Change 6, March 1, 1974
Figure 2-39, Change 5

- 1) Pin number J was not labeled in Figure 2-39.
- 2) Diode shown on the attached sheet is present in Figure 2-24, but missing from 2-39.

Errors in this switch
reported in Drawing
Error Report #2

Diode should be added here

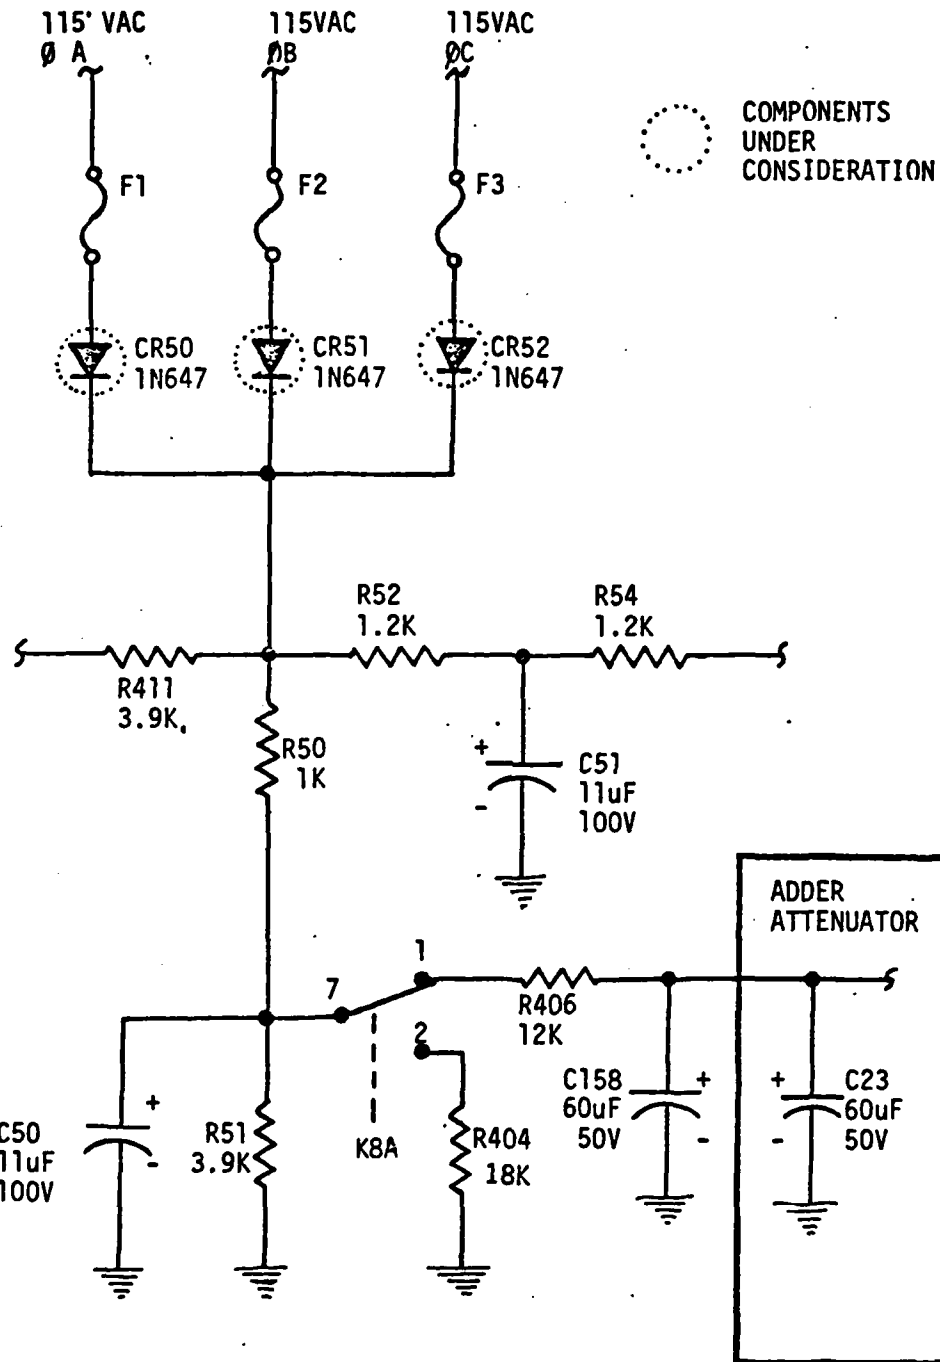
INVESTIGATION REPORT F-4C-1

If any of the diodes CR50, CR51, or CR52 in the Control Amplifier were to fail shorted then open, capacitors C50, C51, C158, and C23 may fail as described in Design Concern Report F-4C-7. For the effect each failure has on the aircraft, see the following Investigation Reports:

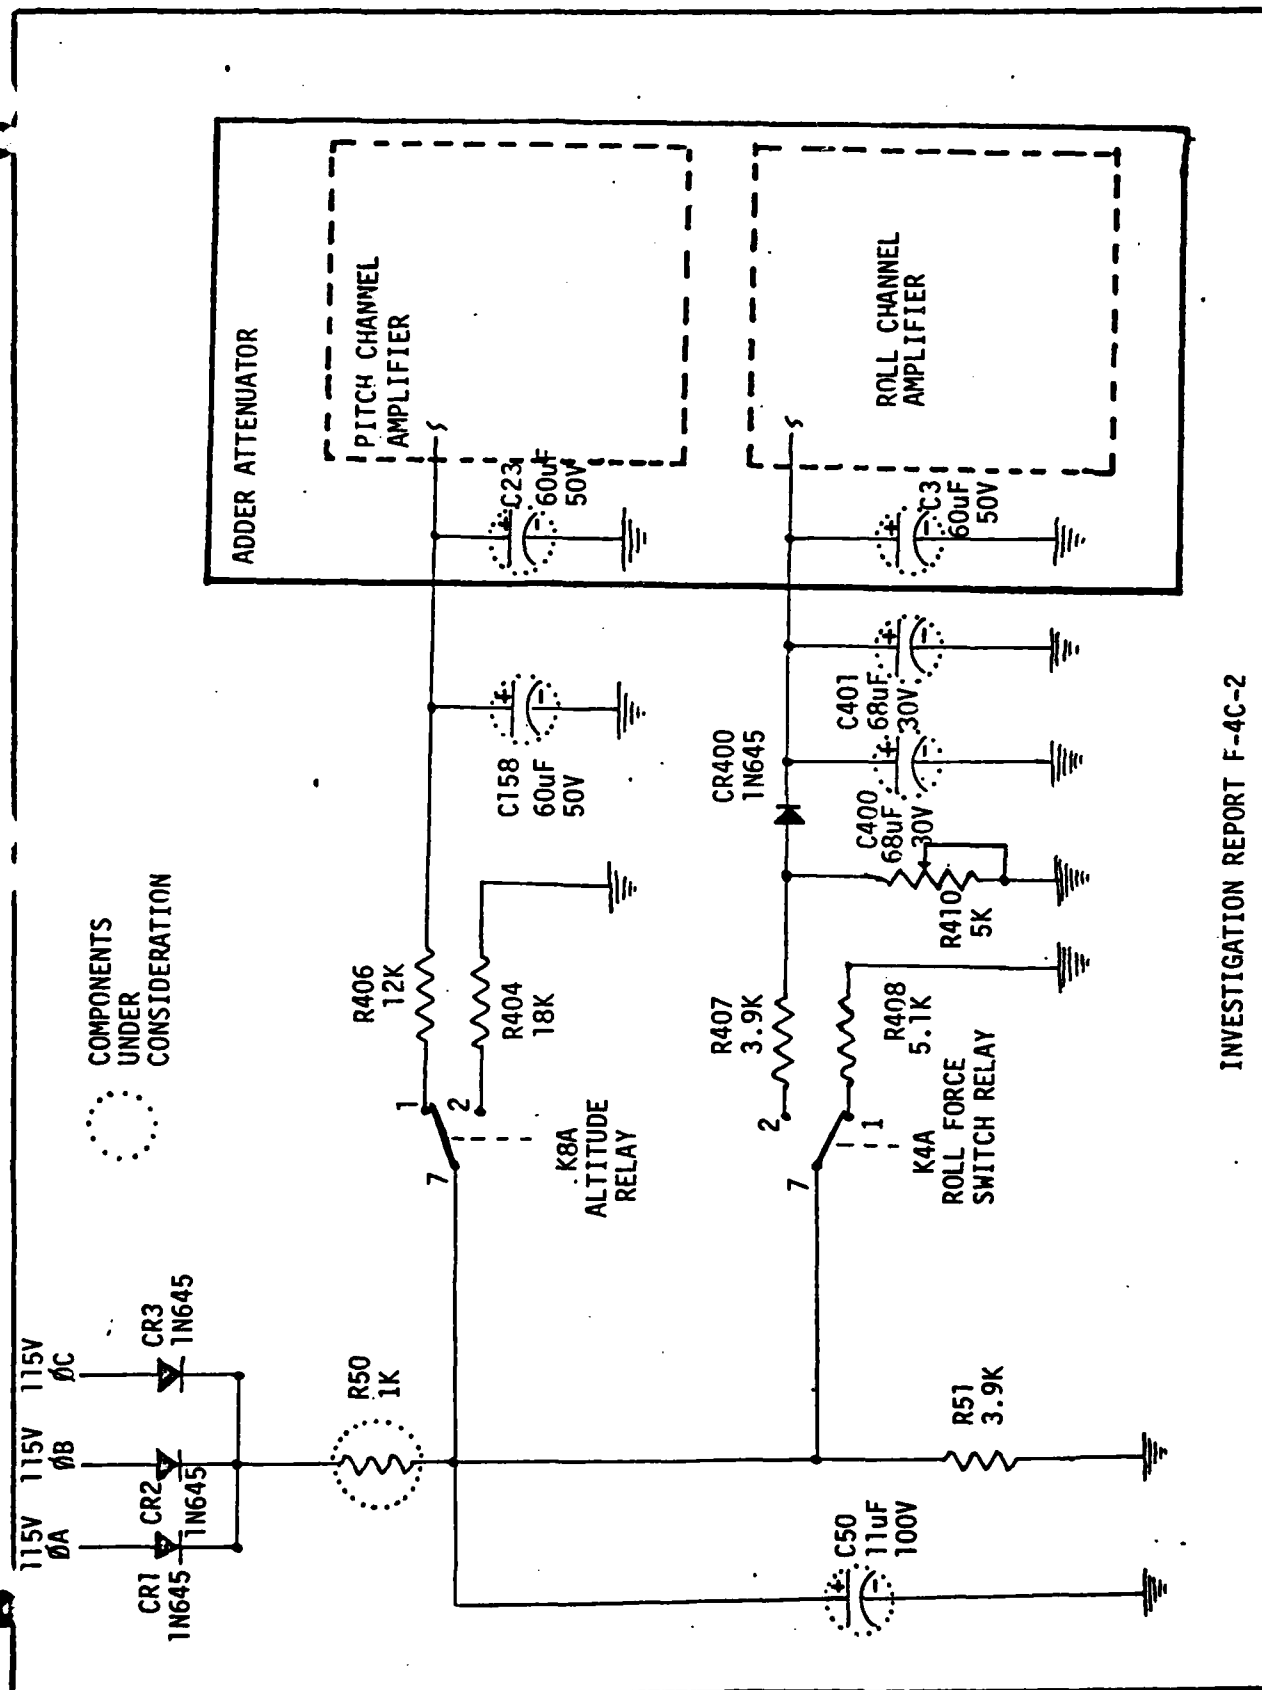
INVESTIGATION REPORT F-4C-2

The pitch amplifier provides normal amplification of signals from the CADC when in the altitude hold mode. When making transitions to and from the altitude hold mode this amplifier fades the altitude hold signal to assure a smooth transition. If capacitor C23 in the Adder Attenuator or capacitor C158 (C158 was not identified as a high failure item but is included here since it has the same effect as C23) in the chassis wiring fail in the shorted mode, the fade effect of this channel will be inhibited. Also, the error signal from the CADC will always be passed by the Adder Attenuator thus opposing pilot controlled pitch maneuvers.

If capacitor C50 in the chassis wiring fails in the shorted mode or if resistor R50 in the chassis wiring fails in the open mode the fade effect of both channels of the Adder Attenuator will be lost and the autopilot will oppose pilot controlled pitch and roll maneuvers.

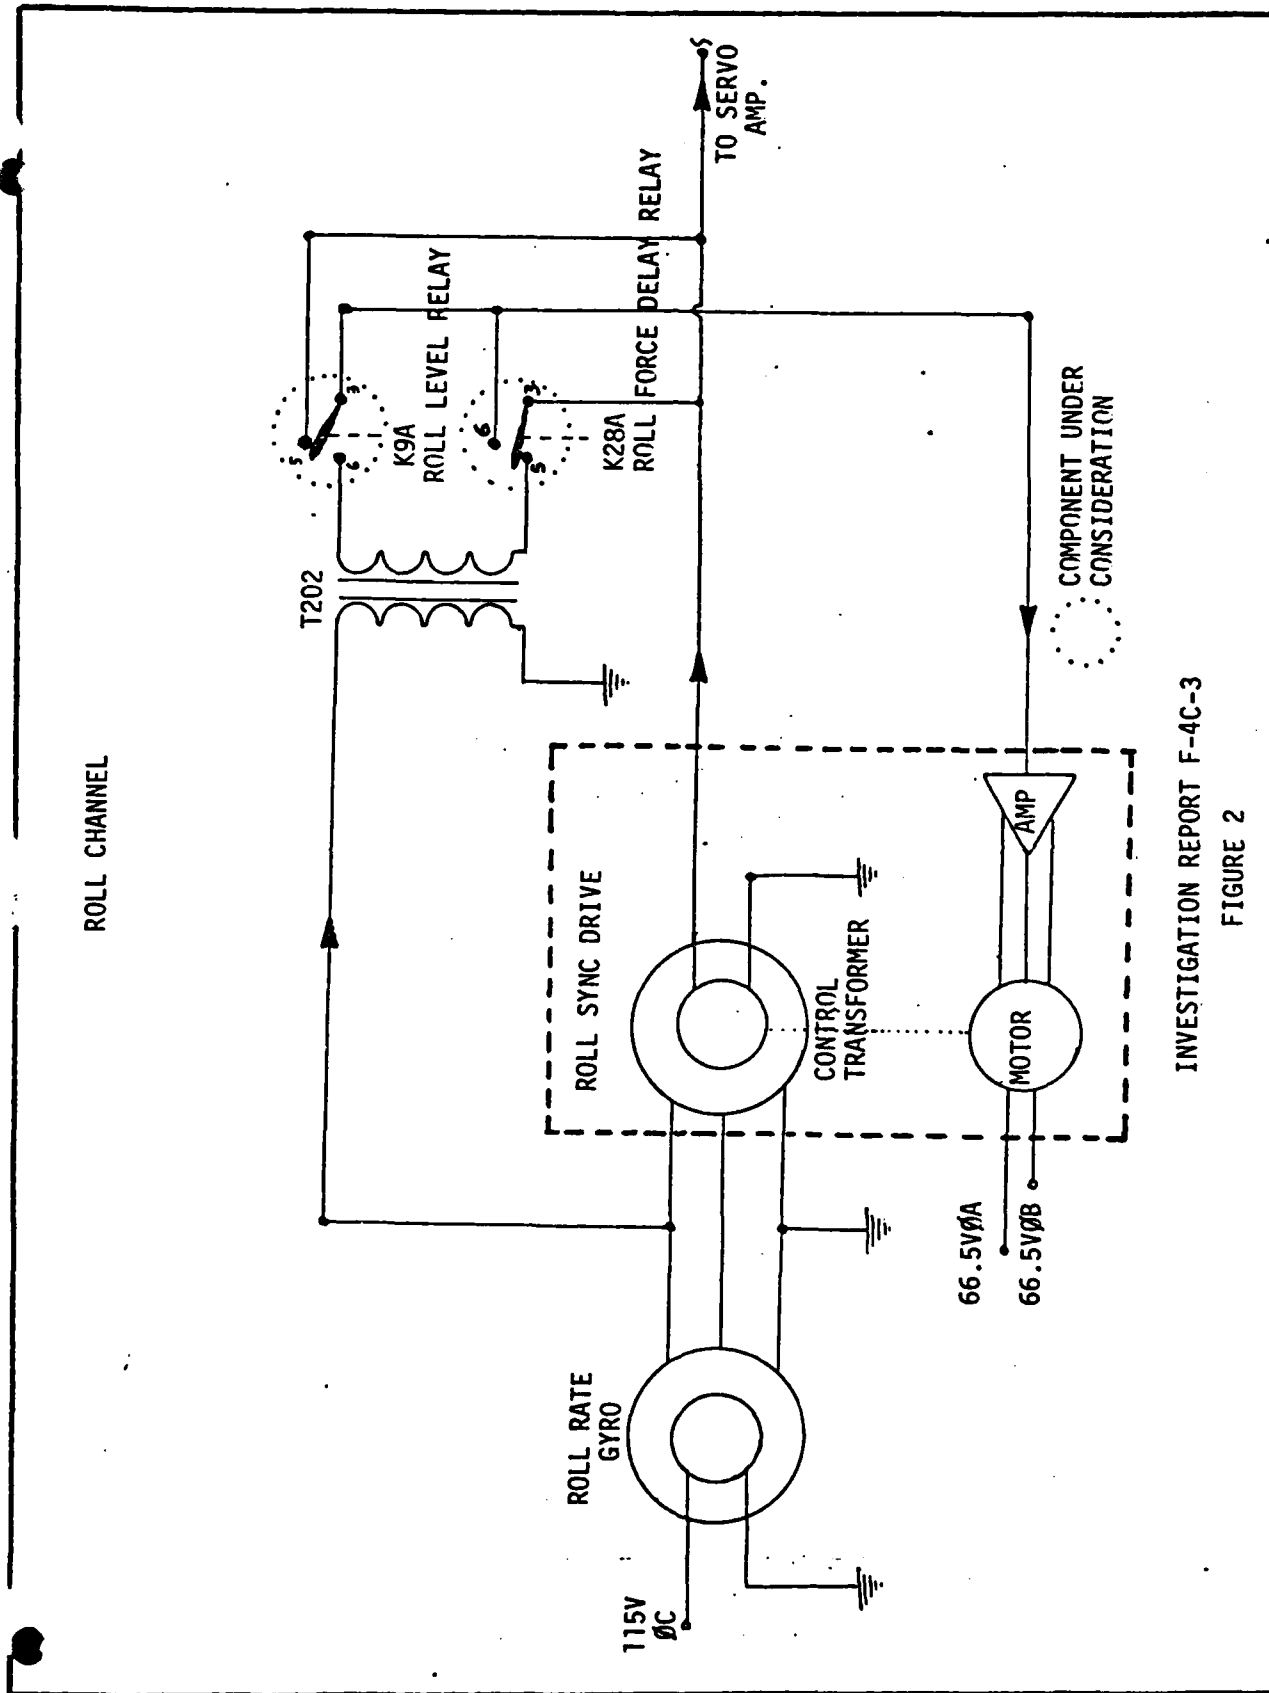
INVESTIGATION REPORT F-4C-3
FIGURE 2

If the 3-6 contact of K9A hangs open (the 3-5 contact then being closed), the Roll Sync Drive control transformer cannot be by-passed (see figure 2). This would mean that with heading hold established, the Roll Sync Drive will still try to maintain its reference attitude. If the Course Sync Drive needs to adjust the ailerons to maintain the course heading, the Roll Sync Drive will oppose it, trying to maintain its reference attitude.
